# The Analysis of Wind Turbine Construction Safety System that Uses Vibroacoustic Diagnostics

M. SZMECHTA\*

Department of Electrical Engineering, Automatic Control and Informatics, Opole University of Technology  
Prószkowska 76, 45-758 Opole, Poland

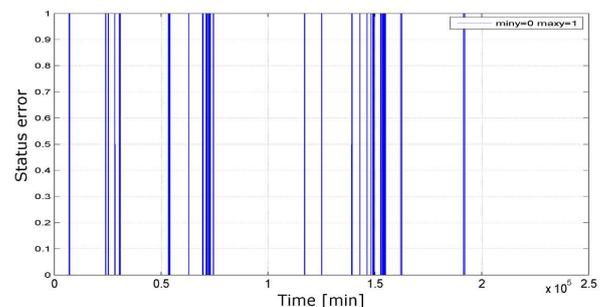
The vector of measurement data consisted of the following values (related to 1 min): minimal, mean, and maximal wind speed, mean rotor speed, minimal, mean, and maximal output power, acceleration error status (binary), wind and nacelle direction difference and nacelle position. In the period of 5 months the mentioned acceleration error occurred 104 times (Fig. 1).

Fig. 1. Occurrences of acceleration error (value = 1) in the whole analyzed data period encompassing above 210 000 data points.

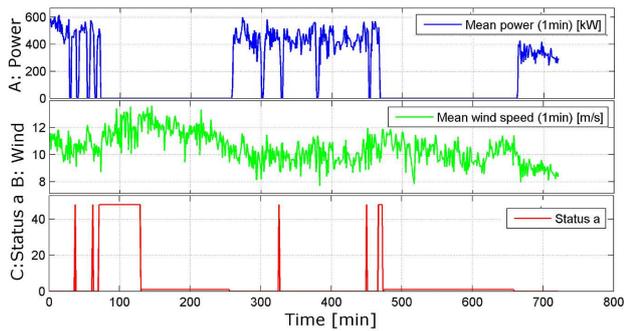
Fig. 2. The time chart of momentary generated power — A, wind speed — B and error signaling — C at selected moment.

Figure 2 magnifies the difference between the value of  $t_{\text{error}}$  and  $t_{\text{error}2}$  indicators. It is clear that the signaling time of wind turbine failure is much shorter than the total downtime of the machine and thus does not represent all losses of electrical energy production as a consequence of its occurrence.

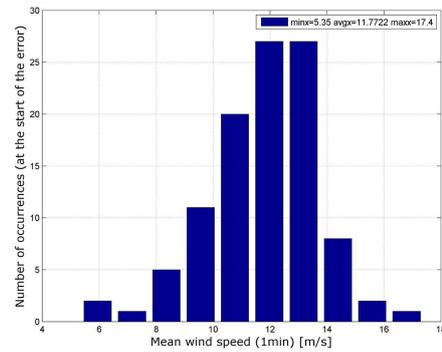
Figure 3 plots a histogram of mean wind speed at which the error signal called by the accelerometer occurred. From the diagram it can be seen that the event

Fig. 3. The histogram of the mean wind speed at the time of an error reported by the accelerometer.

occurs mostly at wind speed of about 12 m/s which may suggest problems with the own frequency resulting from the modification of the mechanical construction of the tower or even foundations, problems with the bearing of the generator or the nacelle itself and blades problems related with their calibration or parameterization of its control system.

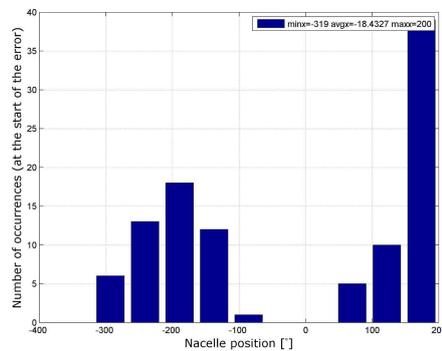
Another characteristic parameter analyzed is the position of the nacelle, which is also an approximate indicator of the direction of the wind. These characteristic peaks can be seen in the histogram in Fig. 4.

Fig. 4. The histogram of the nacelle position at the time of an error reported by the accelerometer.

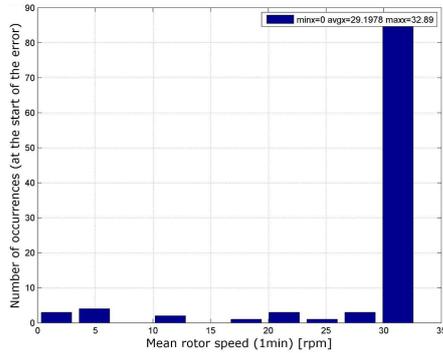
Based on the histogram of mean rotor speed depicted in Fig. 5 it can be concluded that the errors always occur at the nominal rotor speed of about 32–33 rpm. Few values below are due to a sharp deceleration of the rotor and the impact of lower velocity values on one minute averaging of this parameter. In conjunction with the proposals for the wind speed at which it comes to emergency stop of wind turbine caused by the accelerometer there

can be assumed that it comes to it during the phase of starting or ending phase of working pitch control system. These circumstances may indicate problems with the calibration parameters of the blades or some irregularities in the control and regulation system.

Fig. 5. The histogram of the mean rotor speed at the time of an error reported by the accelerometer.

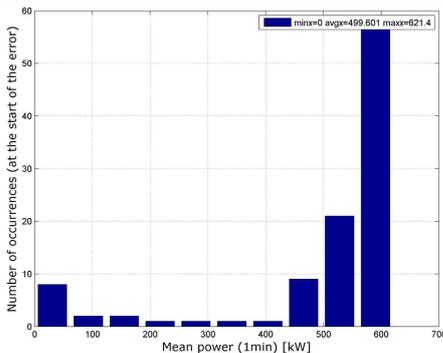
The results presented in Fig. 6 illustrate the full range of produced power from 0 to 630 kW according to the wind turbine controller factory settings. More precise results are showed in the histogram of average momentary power production at the moment of the fault indicator reported by the accelerometer included in Fig. 6. It is clearly visible that the emergency stop of wind turbine occurs mainly at power productions close to the nominal value of wind turbine. This situation is not directly related to the cause of irregularities, but is the direct cause of large losses of renewable energy which cannot be produced.

Fig. 6. The histogram of the mean generated power at the time of an error reported by the accelerometer.

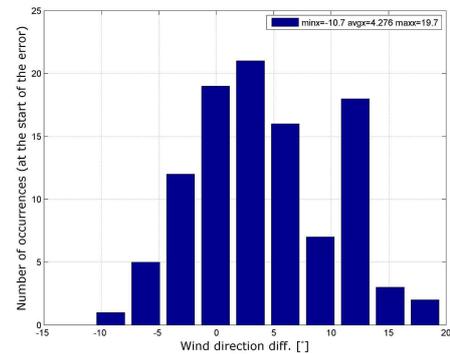
setup value of the controller is set to 0, which means the overlapping of both operational directions, and the measured value is wind and nacelle position difference. Figure 7 shows the dependence of the error signal reported by the accelerometer in the nacelle, depending on the difference in wind and the nacelle direction at the time of its signaling through the construction safety system of the wind turbine. The drawing shows a certain asymmetry in the distribution of data points relative to the 0 value. This asymmetry is clearly visible on the histogram of the difference in wind and nacelle direction. Such a symptom may indicate irregularities in the bearing system of the generator, construction and calibration of the blades itself or incorrect parameterization of the pitch control system. This situation can also be further affected by strong one-sided lateral wind gusts occurring at the location of the wind turbine.

Fig. 7. The histogram of the wind and nacelle position difference at the time of an error reported by the accelerometer.
