The Mechanical and Brittle Properties of Gas Pipeline in Service[†]

M. HAGAROVÁ*, J. CERVOVÁ, M. FUJDA, M. MIHALIKOVÁ AND A. LIŠKOVÁ
Institute of Materials, Faculty of Metallurgy, Technical University of Košice, 042 00 Košice, Slovakia

The paper deals with the determination of mechanical and brittle properties of gas pipeline after more than 40 years in operation. The heat affected zone in weld of pipeline is the risk area in terms of embrittlement structure, which resulted in an increase of yield strength and shift of transit temperature to more positive values. The specimens were cut from heat affected zone for this reason. The tensile test according to ISO 6892-1 showed the increase in yield strength: it had a value of 295 MPa at the beginning operation and 400 MPa after more than 40 years in pipeline operation was recorded. The transition temperature at the value of 20 °C was determined by using the Charpy impact test according to EN 10045-1. The operators of gas pipelines report that the mean temperature on the outer surface of pipe is about 4 °C during the winter. The risk of brittle fragile is very likely if the transition temperature is higher than operating temperature.

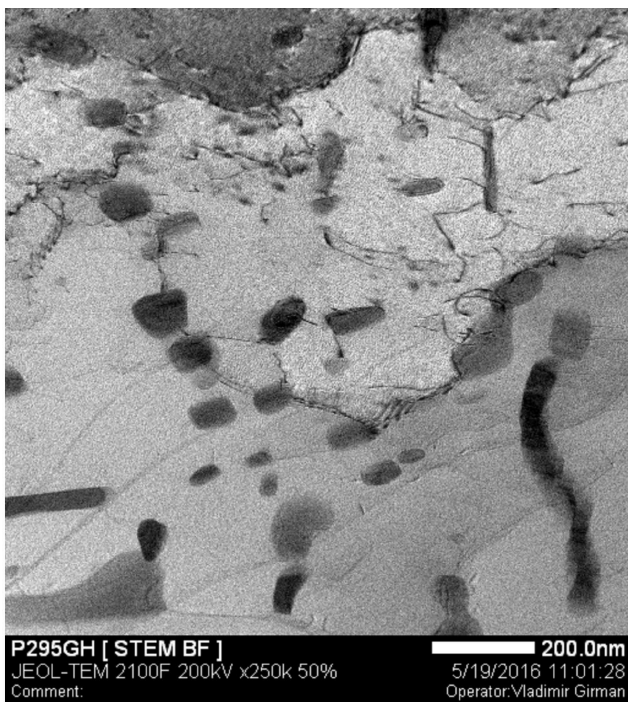
This process is accompanied by increased strength of the material. The ageing process was very likely going in steel structure during long-term operation of pipeline and led to another increase in strength. The precipitates were detected by means of transmission electron microscopy on the basis iron carbide in HAZ area, see Fig. 1.

Fig. 1. Iron carbides particles on the dislocations, TEM.

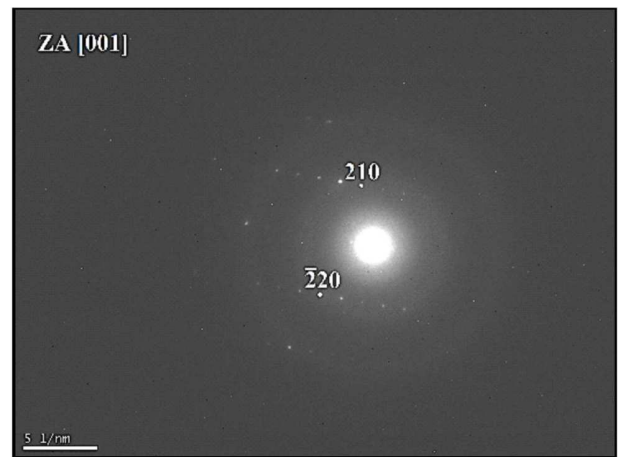
The measurement of selected reflections proved that the distance 4.11 nm^{-1} or 4.82 nm^{-1} , as the case may be, correspond to the Fe_3C (210) and (-220) in the reciprocal space, see Fig. 2. Precipitates of this size could be effective barriers to the movement of dislocations and contributed to strengthening of the structure [12].

Fig. 2. Diffractogram of iron carbide, TEM.

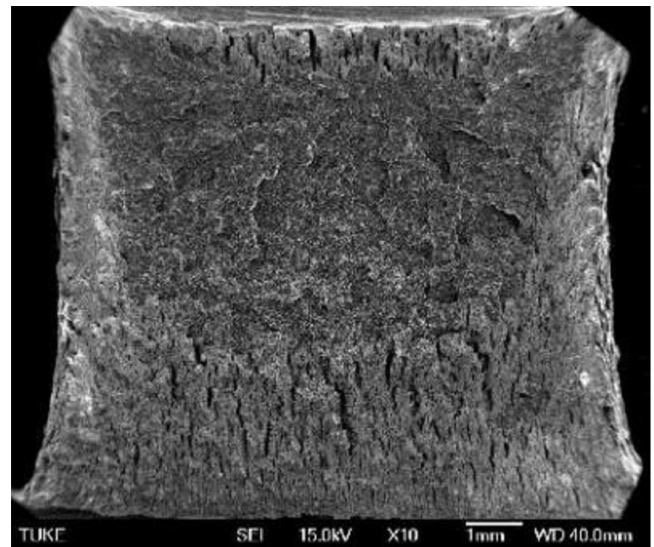
Fig. 3. Fracture surface of specimen W03; $K = 27$ J.

Analysis of fracture surface of specimen W03, documented in Fig. 3, obtained by fracture of the specimen at the Charpy test conducted at +20°C, showed a mixed character of failure. Transcrystalline brittle failure was located in the middle of the fracture area. Transcrystalline ductile failure was situated in the lower part of the specimen. Cavity size with inclusions was larger than others, Fig. 4. Separation of inclusions has created cracks on the cavity walls [13].

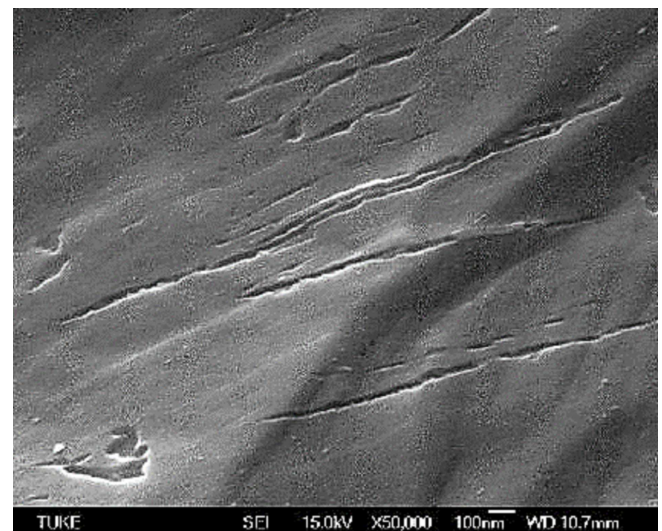
Fig. 4. Cavities on the surface of the sample W03.

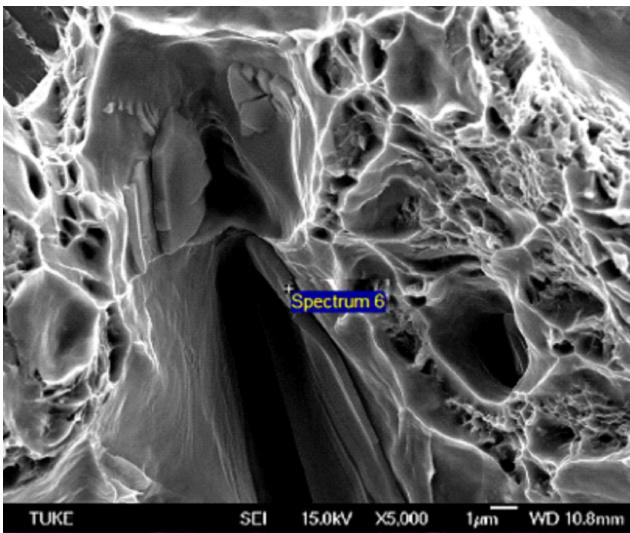
Fig. 5. Fracture surface with particles, SEM.

The transgranular ductile fracture areas were located at the bottom of these samples. The inclusions were observed in the wells of grain, see Fig. 5. It is possible to observe particles which were identified by energy dispersive X-ray (EDX) analysis, Fig. 6, by scanning electron microscope as sulphides of manganese and iron in the walls of ductile failure shown in Fig. 5: MnS respectively MnFeS [14].

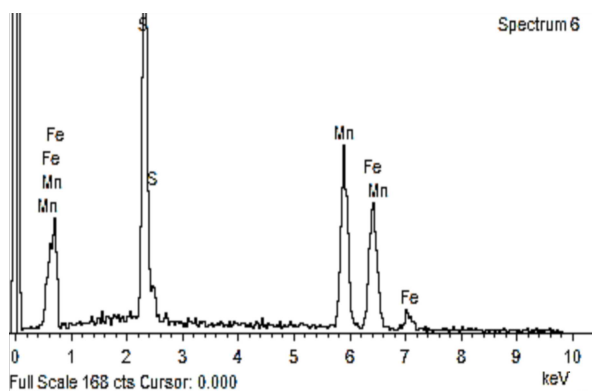
Fig. 6. EDX spectrum of the particles.

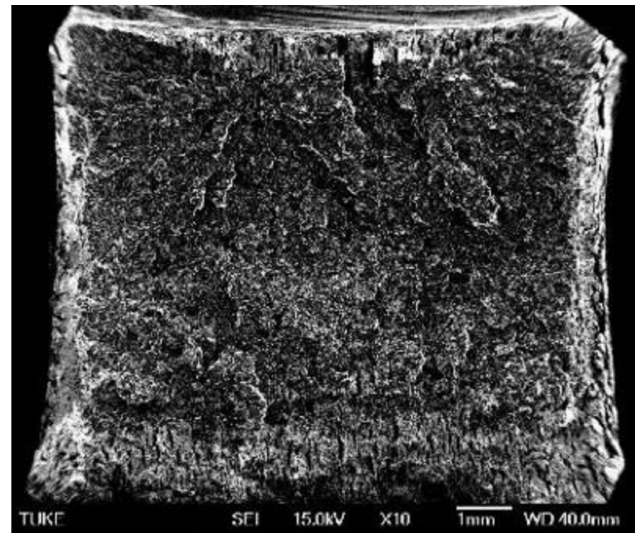
Fig. 7. Fracture surface of specimen W05; $K = 20$ J.

Figure 7 shows fracture surface of specimen W05 broken at 0°C. The fracture surface shows minor proportion of transcrystalline ductile failure. The edges of holes of transgranular ductile fracture were slightly rounded which corresponds to higher values of plastic deformation. The presence of facets was the evidence of intergranular brittleness of ferrite. This was formed mainly

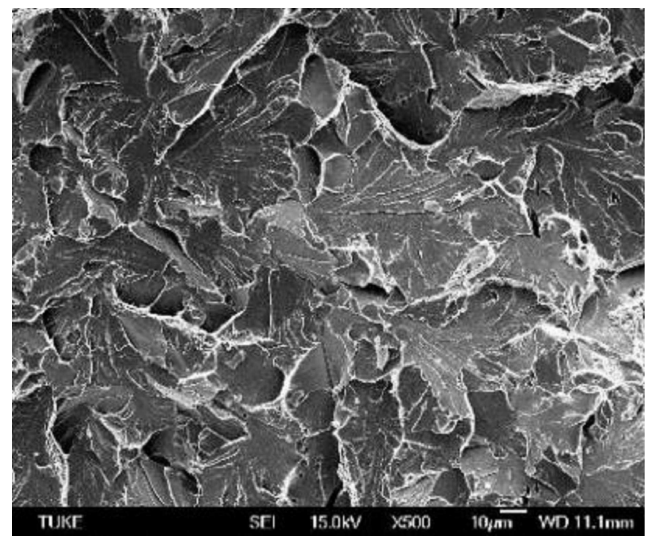
Fig. 8. Transcrystalline brittle failure of fracture surface of sample W05.

as a result of segregation of impurity atoms at the grain boundaries. The specimen edges were little deformed. The cleavage facets of transcrystalline fracture formed major proportion of fracture surface. Figure 8 shows transcrystalline brittle failure of fracture surface of specimen W05.

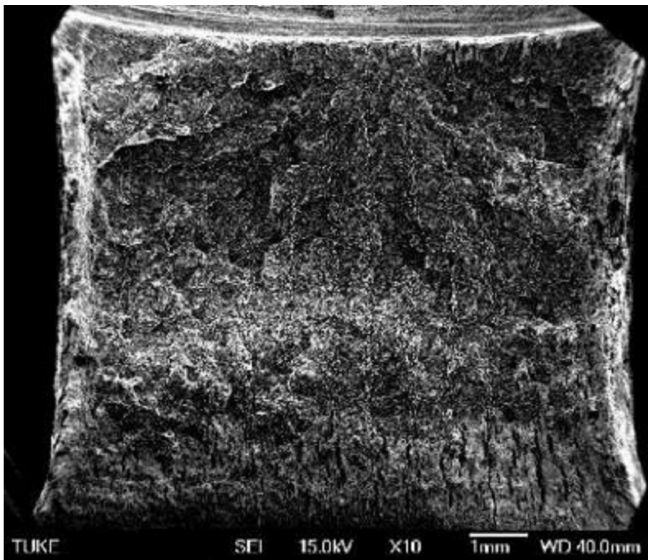
Fig. 9. Fracture surface of specimen W07; $K = 14$ J.

Figure 9 shows fracture surface of specimen W07, fractured at -10°C . The character of failure was mixed and the major proportion of fracture surface showed transcrystalline brittle failure, Fig. 10. The brittle and plastic ones (area with pitted surface morphology) were in both areas of failure.

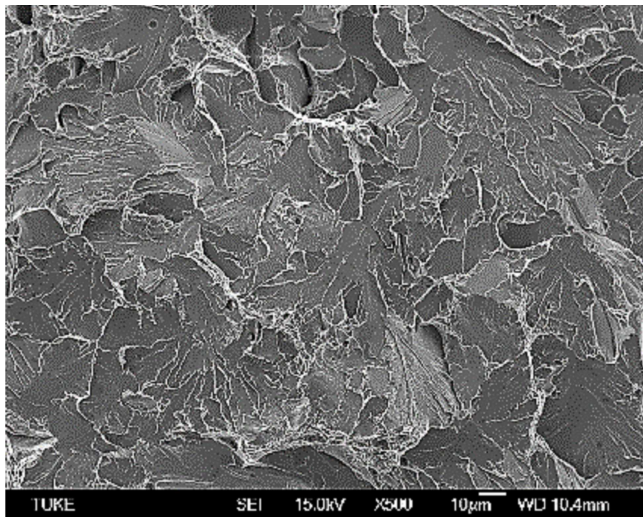
Fig. 10. Transcrystalline brittle failure of fracture surface of sample W07.
