Special Issue of the 6th International Congress & Exhibition (APMAS2016), Maslak, Istanbul, Turkey, June 1–3, 2016 Theoretical and Experimental Study of a Cement Finish Mill

R. Magraoui^{*} and M. Temmar

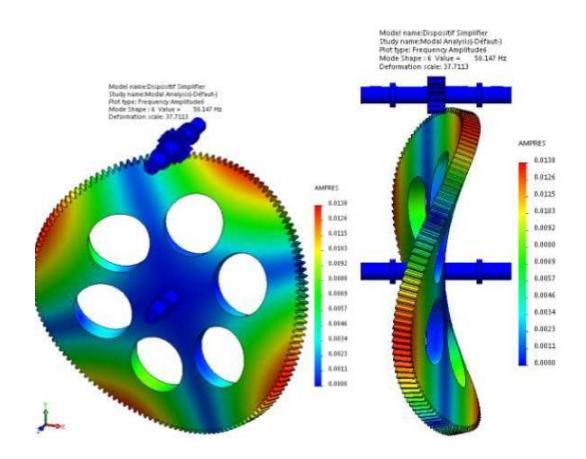
Fig. 5. Sixth vibration mode of gear system.

The modes influence the dynamic behavior of the structure, especially the fifth and the sixth vibration modes (Fig. 5), which are nearest to the engaging system frequency of 48.75 Hz, based on the results of vibration analysis given by the spectra.

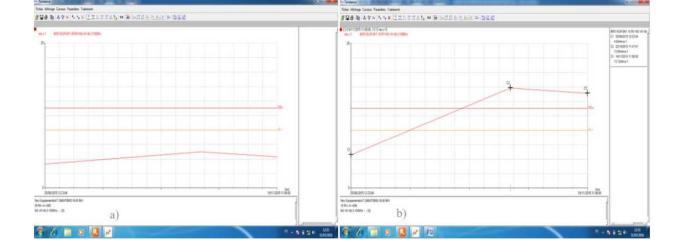
| | | Concerned | | Overall vibration | Overall vibration | |
|---|---|---|--|---|---|---|
| 22.10.2015 | | No. 10. Meshing fault in gear No. 2 | At the output of the command, and in parti- cular on the bearing No. 10, the overall level of vibrations is amplified | 05.01 | 13.90 | Considerable im- provement in the level of vibrati- ons in the reducer No. 1 |

Fig. 6. Vibratory trend of BK 01 on the landing (a) No. 9 in the horizontal direction, (b) No. 10 in the vertical direction.

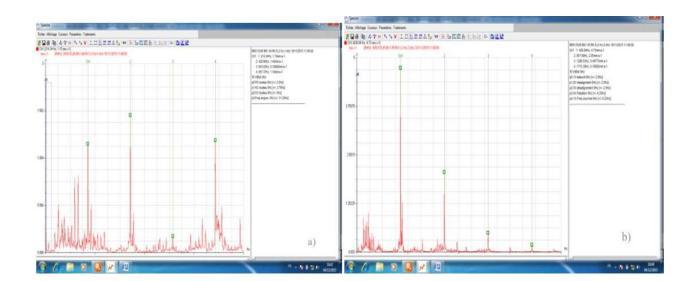
- Presence of a gearing fault on the reducer No. 1, where the gearing frequency is 428.68 Hz.
- Presence of a gearing fault on the reducer No. 1, where the gearing frequency is 428.7 Hz and a frequency modulation of 16.8 Hz. This frequency is

Fig. 7. Spectrum taken on the bearing (on the October 19^{th} , 2015) (a) No. 4 in the horizontal direction, (b) No. 5 in the horizontal direction.

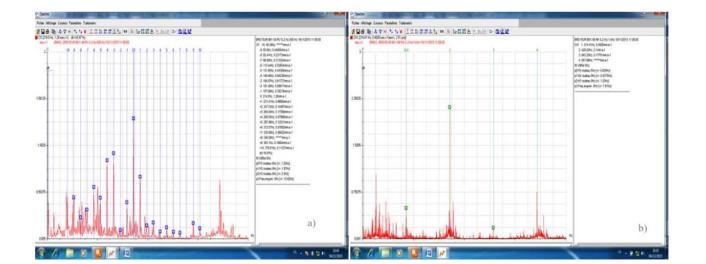
Fig. 8. Spectrum of bearing (on November 19^{th} , 2015) (a) No. 4 in the vertical direction, (b) No. 6 in the horizontal direction.

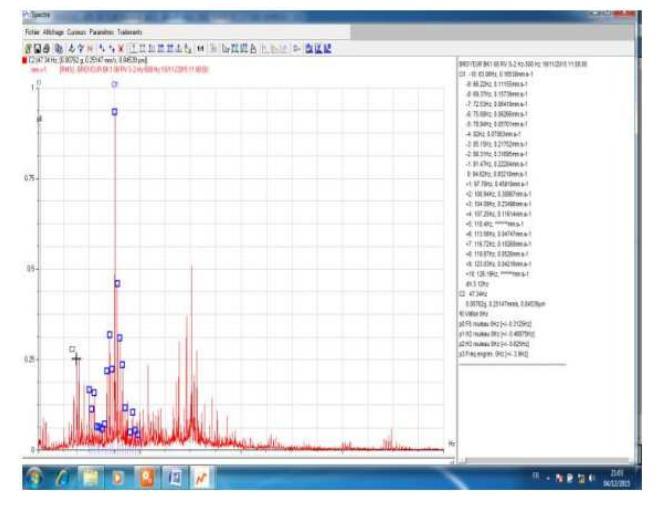
- Presence of a meshing fault on the gearbox No. 2, where the gearing frequency is 47.34 Hz with a modulation frequency of 3.12 Hz, concerning basis to the basis of gear pinion on the second harmonic of 94.67 Hz,
- Presence of bearing fault on the reducer No. 1, where the gearing frequency is 47.31 Hz.

Fig. 9. Spectrum taken on the landing No. 8 in the vertical direction of BK01 (on November 19^{th} , 2015).

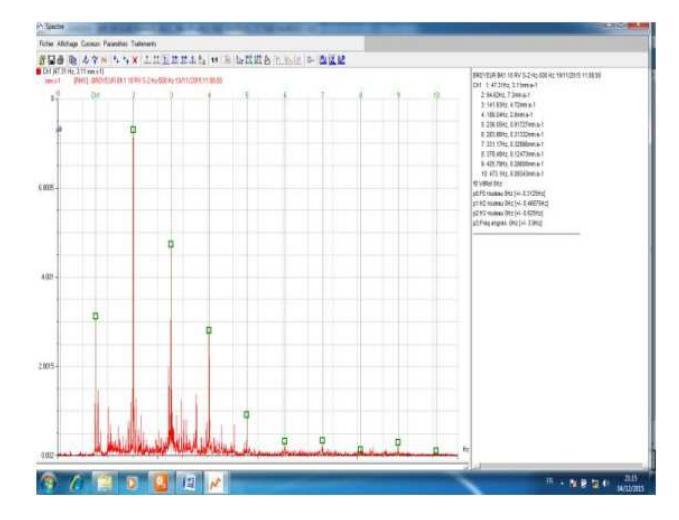
| | | Concerned | | Overall vibration | Overall vibration | |
|---|---|---|--|---|---|---|
| 19.11.2015 | | Reducer No. 2. Ad- vanced usury on the profile of the flanks of the pinion and the toothed ring | | 04.32 | 13.10 | |

Fig. 10. Spectrum of bearing No. 10 in the vertical direction of BK01 (on November 19^{th} , 2015).
