Failure Analysis of a Lower Wishbone

Teknorot Automotive Product Industry, Research-Development Center, Düzce, Turkey

It is known that wishbone is a hinged suspension link between the chassis and the suspension hub that carries the wheel. This paper describes the failure analysis of a lower wishbone (control arm) in a light commercial vehicle which had been involved in service loading. The wishbone was analyzed in two ways. In order to investigate reason of the failure, finite element modelling was conducted to evaluate stress distribution and reliability of wishbone. Moreover, the metallographic and hardness evaluation were made on weld seam of the failed part. From metallographic observations, the presence of porosity was found in weld seam. Hardness distributions from the parent material to weld region are measured in the expected range. The results of finite element analysis and metallographic examination showed that the fatigue failure was initiated from highly stressed region in weld seam, and the presence of porosity stimulated crack initiation as well as crack growth.

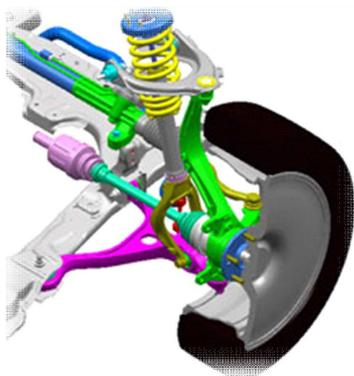
Lower control arm (Fig. 1) is one of the most important suspension parts of vehicle body that enables the wheel to keep its desired position and provides upwards and downwards movement of the wheel in safety.

Fig. 1. Lower wishbone painted purple.

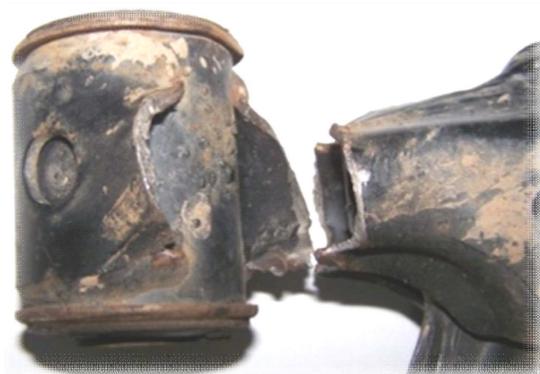
Variable forces may lead the fatigue fracture on parent body and connection region weld seam (Fig. 2). During movement of the vehicle, fracture of lower control arm inflict heavy damage economically and vitally.

Fig. 2. Failure wishbone.

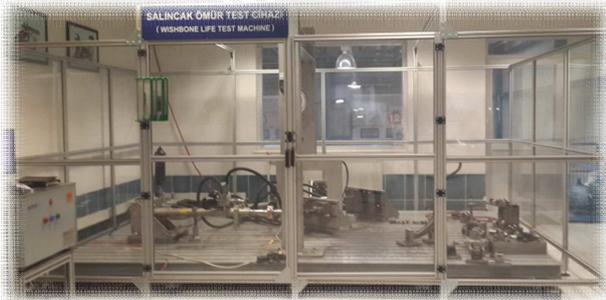
The lower control arm has been manufactured with sheet forming and welded with metal active gas (MAG) welding. All of our developed products have been tested by fatigue test bench which is located in R&D Center (Fig. 3). According to fatigue test results, the lower control arm has not ensured desired performance repeatedly. With applied loading on the lower control arm, fracture failure has detected lower cycles than we expected. All of experimental studies show us that fracture region has not changed.

Fig. 3. Fatigue test bench.

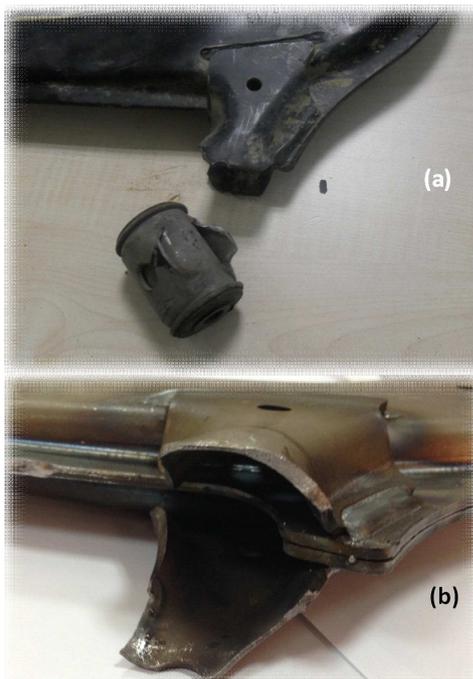
Fig. 4. Failed wishbone after fatigue test.

As seen on the photo (Fig. 4) fracture region is the same. It is important that crack fracture has started beginning from the weld seam and connection area bush tube between bracket.

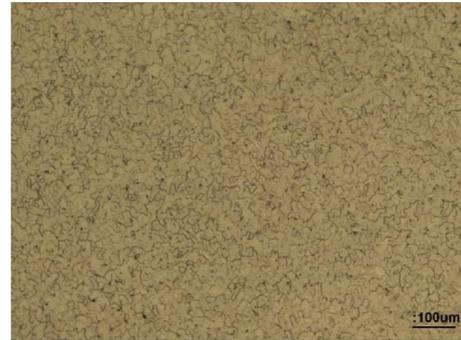
Figure 5 shows the microstructure of sheet metal used in manufacturing of wishbone. Analysis shows that the microstructure of the sheet metal is ferritic steel.

Fig. 5. Microstructure of sheet metal used in manufacturing of wishbone.

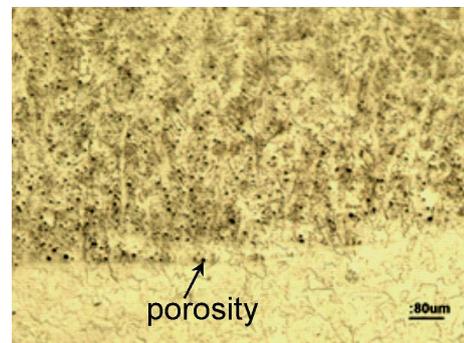
Fig. 6. Microstructure of weld junction region.

Base metal and welding metal is given in Fig. 6 and examined together, it is noticed that the gas gap is located in the welding area. Especially in the base metal and welding metal transition areas show the concentrations of the gas gap significantly. It is known that the formation of gas gap is related to the inability of the gas mixture amount [1]. Taking into consideration that the prototype used in the gas mixture flow is inadequate for the formation of porosity, the experiment of welding is made by increasing the gas flow.

Although the welding of the gas mixture is suitable, the welding area cannot be sent to a sufficient quantity of the gas mixture which leads to the cause of undesirable porosity. Metallographic examination of the welding seam gas gaps that may develop under dynamic stress to accelerate the formation of fatigue cracks in part, in a sense, it was found that the formation of cracks increases the sensitivity.

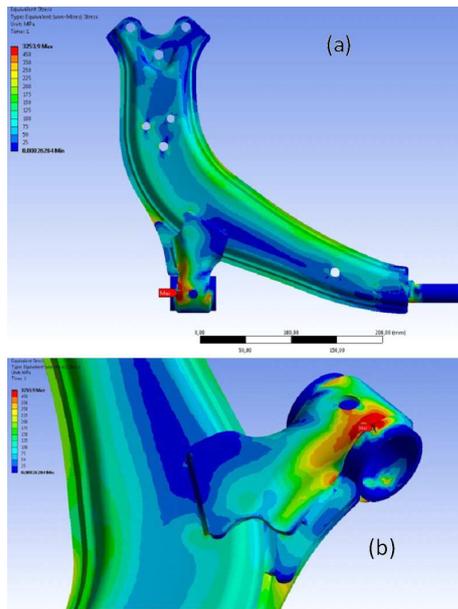
Investigating reason of the failure, finite element (FE) modelling was conducted to evaluate stress distribution that shows us that fracture starts from the some region within lower cycles than we desired (Fig. 7). Inferring from this study, porosity causes the fracture on the weld seam.

As it is known that the porosity on weld seam increases the stress concentration and thus porosity leads to increase of stress value locally. If porosity area corresponds to a point on the outer notch or an area on the notch, it is easy to show up the effects on it. With experiments and evaluations, the microstructures porosity (Fig. 8) level was appropriate. The welding conditions have the most suitable value for this study. After the test of prototypes

Fig. 7. (a) General stress (Von Mises) distribution of wishbone subjected to test loading, (b) detailed appearance [2].

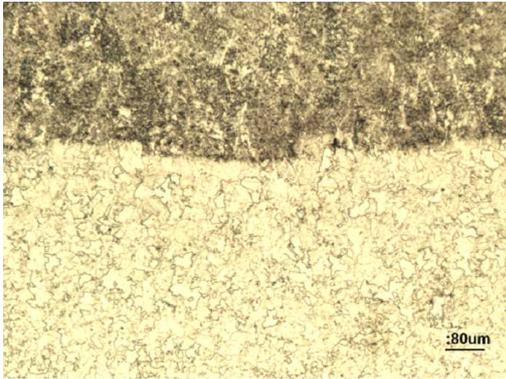
Fig. 8. Weld junction region for the parts welded with appropriate gas flow.

which includes all the three samples which were tested, the fatigue life increase of those parts's porosity probability was blocked.
