Selected papers presented at the Eleventh Annual Conference of the Materials Research Society of Serbia, YUCOMAT 2009

Studying Efficiency of NDE Techniques Applied to Composite Materials in Aerospace Applications

K. DRAGAN^a AND W. SWIDERSKI^b

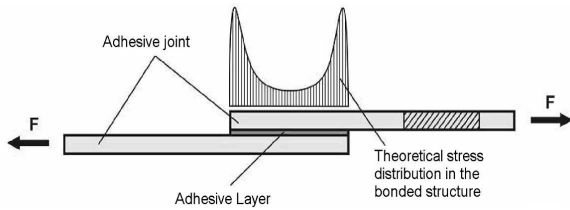
Fig. 1. Stress distribution in the bondline.

Adhesive joints are commonly used in the manufacturing of aerospace components (the so-called *bondlines*). In particular cases, this bonding technique is supposed to be more efficient than regular ones, such as bolts, rivets etc. Moreover, it allows for the integration of different materials (composite-to-metal, skin-to-honeycomb, etc.), as well as the conduction of a possible future repair. However, such joints may collapse because of the presence of manufacturing faults, operating cyclic loads and impact damages. Depending on a particular bondline and a type of structure, the inspection of adhesive joints may be accompanied by some problems. At the maintenance stage, because of a specific stress distribution and operating loading cycles, critical areas may propagate from bondline edges, as shown in Fig. 1.

In many aerospace structures, particularly used in small-size airplanes, sandwich panels stiffened with foam-to-core material are frequently used. In such panels, continuing loading and specific stress distribution (see Fig. 1) may cause disbonds between composite layers and cores. The corresponding sample was produced by joining a glass epoxy and a foam core. Disbonds of different size and shape were introduced into the sample to allow for the evaluation of testing efficiency.

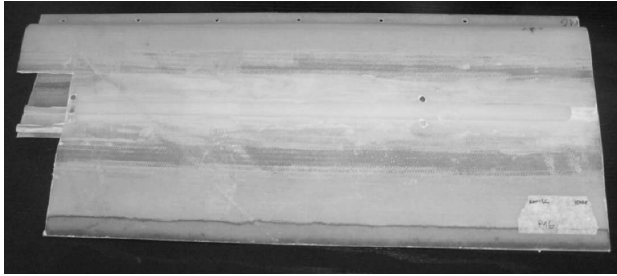
a Poland-made glider PW-5 (Fig. 2).

Fig. 2. Rudder of the PW-5 glider.

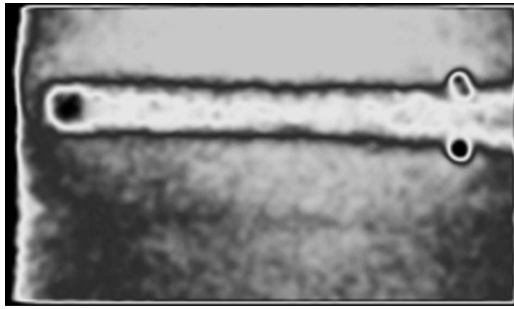
Fig. 4. IR thermogram of the PW-5 rudder.

The next inspection NDE technique has been infrared (IR) thermography, which can be implemented in both passive and active modes. The passive IR thermographic testing is applied to objects of whose temperature is different from the ambient one, whether it is due to natural or exploitation reasons. Typically, evaluation of material defects is possible in the active mode where transient thermal fluxes are stimulated in samples under test by means of external heat sources [18, 19]. Several inspection techniques have been developed, merely to mention pulsed thermography, step heating, lock-in thermography, vibrothermography, etc. In all these procedures, either a reflection or transmission inspection procedures can be implemented. In the reflection procedure, a thermal source and an IR camera are located on the same side of a tested object, while in the transmission procedure two opposite object surfaces are respectively heated and monitored. In the IR thermogram of Fig. 4 (pulsed thermography, reflection method), the quality of the rudder glue joint can be easily evaluated.

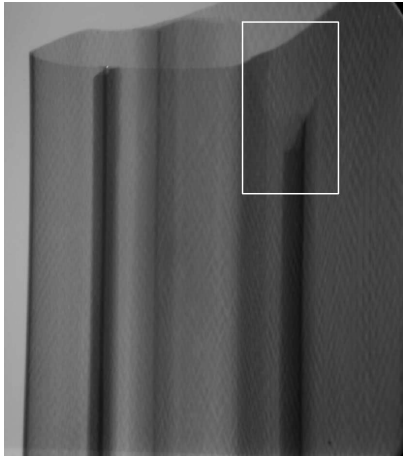
Fig. 5. Röntgenogram of the PW-5 rudder.

Another inspection solution was X-ray radiography. Its advantage is the direct imaging of a sample internal geometry. In Fig. 5, both the bondline and the missing part of the internal rib are seen. The disadvantages of X-ray radiography are the necessity to access both sides of samples and insensitivity to certain types of defects, e.g. delaminations [13].

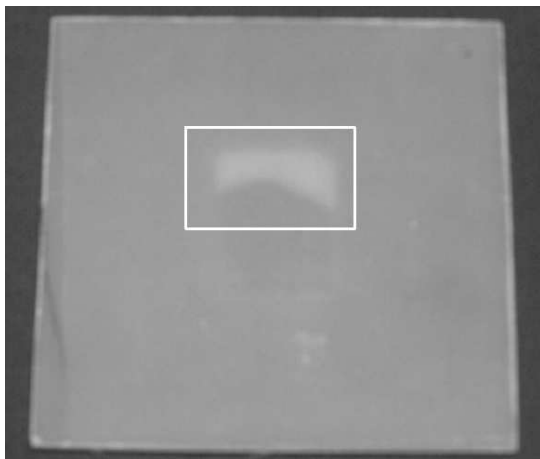
Fig. 6. Wing skin sample with a disbond.

as mechanical impedance analysis and shearography [2].
The next studied parts represented thicker aircraft structures (e.g. wing skin — see Fig. 6) adhesively joined to substructure (spar, rib).

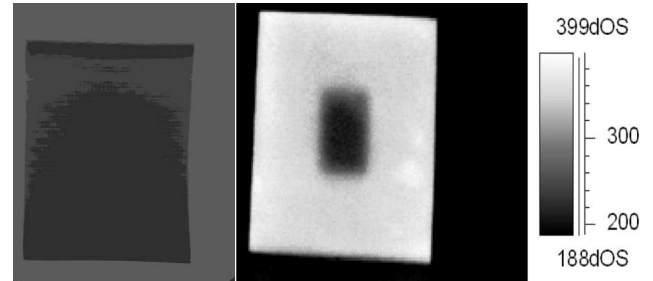
Fig. 7. Wing skin sample with a disbond results collected by using (a) X-ray radiography; (b) IR thermography.

Figure 7 demonstrates the images collected by using X-ray radiography (a) and IR thermography (b) lock-in technique, phasegram.

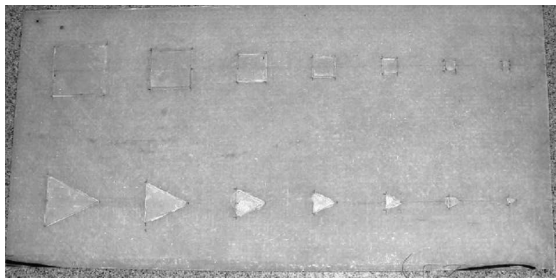
Fig. 8. Bondline between glass epoxy and foam core.

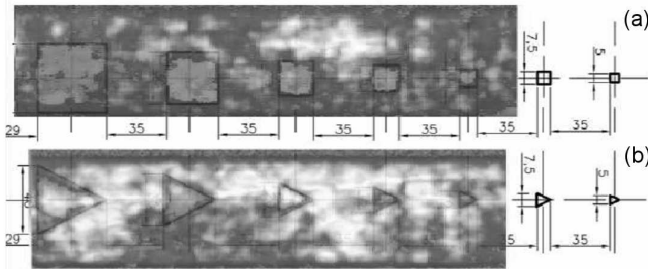
Fig. 9. Ultrasonic inspection results. (a) top and (b) bottom of sample from Fig. 8.

Figures 9a,b exhibits the data collected by using an ultrasonic phased array system. The visualization technique based on colours enabled the evaluation of defect depth, as well as the size and shape description.

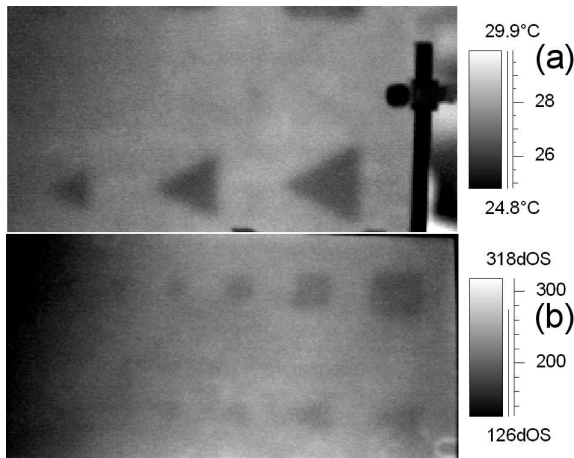
Fig. 10. Thermography results; (a) results of the IR thermogram; (b) results of lock-in IR thermography technique.

The corresponding results are presented in Fig. 10. The top image (a) shows the IR thermogram of the sample from Fig. 8 obtained in the transmission mode. The sample phasegram obtained by applying the lock-in IR thermography technique is shown on the bottom (Fig. 10b).

The same sample was also checked thermographically to demonstrate a good visibility of all defects.

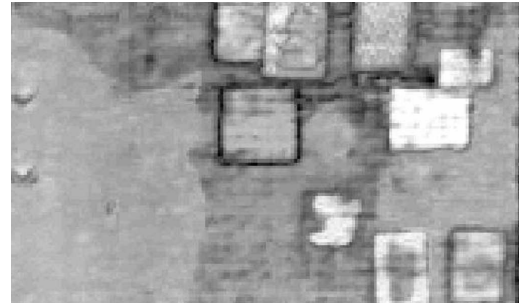
Fig. 11. Ultrasonic inspection result.

Figure 11 shows the result of the ultrasonic detection of foreign inclusions and delaminations in a laminar carbon fiber composite. All defects are clearly seen by applying the pulse-echo ultrasonic technique. Assessment of defect size and depth is also possible while analyzing ultrasonic data.

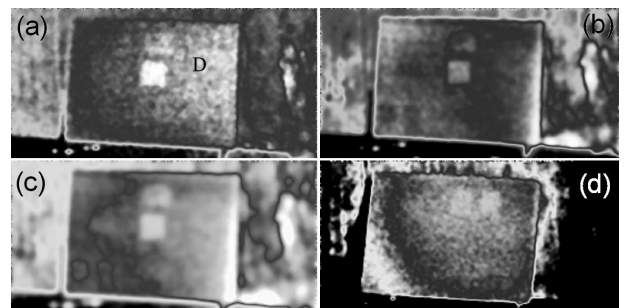
Fig. 12. IR thermography inspection results. (a) transmission procedure — the optimum source image, (b) PCA — the image of the 4th principal (c) PCA — the image of the 2nd principal, (d) reflection procedure — the optimum source image.

Both reflection and transmission testing modes have been analyzed. Figure 12 shows the results obtained by applying principal component analysis (PCA). The SNR value between a particular defect area *D* in Fig. 12a (thermogram, transmission procedure) and a neighbor non-defect area has been chosen to compare quality of thermograms. The optimum source image (see Fig. 12a) is characterized by SNR = 6.7. The maximum value of SNR = 8.5 has been observed in the image of the 2nd

principal component (PCA algorithm — see Fig. 12c). The image in Fig. 12b shows the 4th principal component (SNR = 3.5), while Fig. 12d corresponds to the reflection mode.

The IR thermographic inspection of the same sample resulted in the detection of maximum 7 defects from actually existing 9 defects, depending on data processing technique applied.

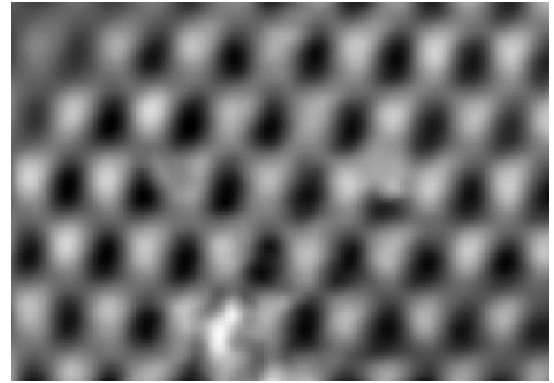
In figure Fig. 14, shearography results are presented for the skin to honeycomb disbonds caused by low energy impact.

Fig. 14. Skin to honeycomb disbonds with shearography.
