# Solid Particle Erosion Behavior of Volcanic Ash/PVC Composites

In this study an attempt has been made to evaluate the solid particle erosion behavior of PVC based composites with various volcanic ash (VA) concentrations (5, 10, 15, 20 and 25 wt.%). VA/PVC composites were prepared by using a twin screw micro-compounder and an injection molding machine. The erosion testing of VA/PVC composites was performed in accordance with the ASTM G76-95 standard at 6 different particle impingement angles (15°, 30°, 45°, 60°, 75° and 90°) and under the pressure of 1.5 bar by using abrasive Al<sub>2</sub>O<sub>3</sub> particles. The morphology of eroded surfaces was examined by using a scanning electron microscope (SEM), and possible wear mechanisms were discussed. Moreover, the surface roughness values of eroded VA/PVC composites were analyzed by using a non-contact laser optical profilometer. 3D surface topographies were also examined.

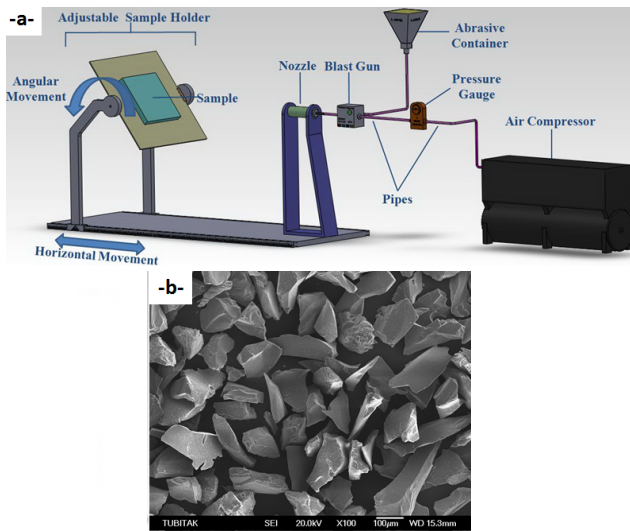
Fig. 1. (a) Erosion test rig, (b) Alumina ( $\text{Al}_2\text{O}_3$ ) erosion particle.

Solid particle erosion tests were carried out according to ASTM G76-07. Figure 1a shows a schematic illustration of the erosion test rig used in this study. Sharp-edge alumina (Al<sub>2</sub>O<sub>3</sub>) particles with a size of 120 mesh ( $\approx 125 \mu\text{m}$ ) were driven by a static pressure of 1.5 bar during 10 seconds. Sharp-edge shape and approximate size (125  $\mu\text{m}$ ) of alumina particles can be clearly seen in scanning electron microscope (SEM) photo shown in Fig. 1b. In this study, samples were eroded under six impingement angles of 15°, 30°, 45°, 60°, 75° and 90°. Samples were cleaned by air blasting before and after erosion tests in order to remove sand and dust particles, and then were weighed in an electronic balance of an accuracy of  $\pm 0.1$  mg.

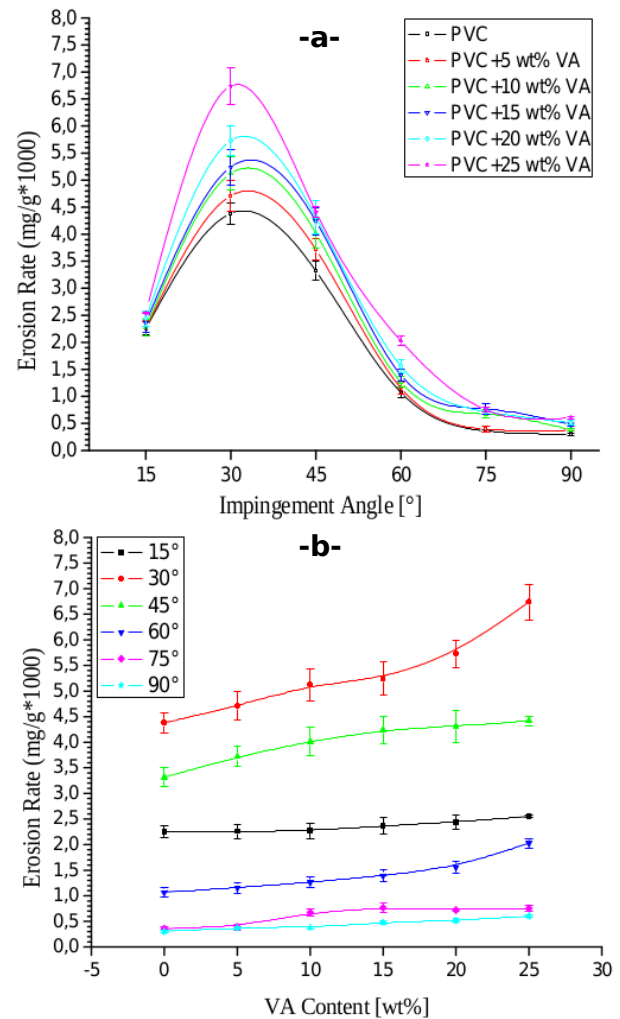
Fig. 2. Erosion rate variation of PVC/VA composites; a) as a function of impingement angle, b) as a function of VA content.

Solid particle erosion results of PVC with the addition of VA are illustrated in Fig. 2. It is clear from Fig. 2a that pure PVC exhibited ductile erosion behavior, and that the maximum erosion rate was observed at the impingement angle of  $30^\circ$ . Additionally the minimum erosion rate of pure PVC was observed at the impingement angle of  $90^\circ$ . This typical ductile erosion behavior was also reported by various researchers [11–13]. It is seen from Fig. 2b that the erosion rate increases almost linearly with the increase of VA content for all impingement angles. Hence, the addition of VA filler does not help in improving erosion resistance of PVC, and the increase in VA content does not change the ductile erosion behavior of PVC. 3D roughness maps of PVC composites are shown in Fig. 3. Colour scale shows the variation of erosion depth for the erosion region.

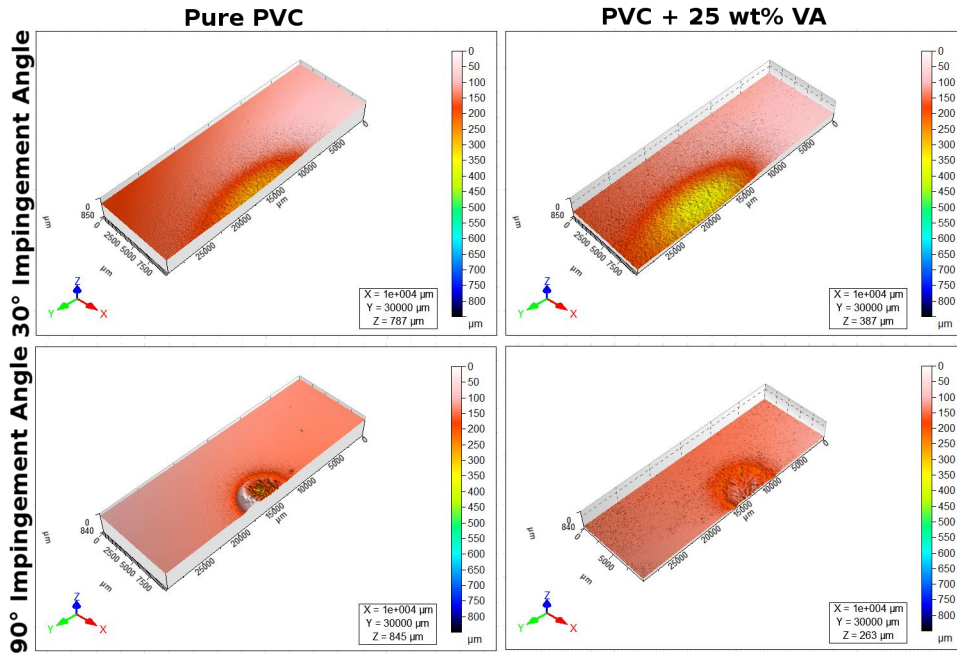
Fig. 3. Optical profilometer scans of pure and 25 wt.% VA-filled PVC.

At  $30^\circ$  impingement angle, elliptic erosion regions were observed, which have almost equal area for pure and 25 wt.% VA filled PVC. Additionally, according to colour change in erosion area, addition of 25 wt.% of VA filler tended to result in a deeper erosion area, which is approximately  $350 \mu\text{m}$ , compared to approximately  $275 \mu\text{m}$

erosion area depth of pure PVC. Thus it can be said that deeper erosion areas obtained with the increase of VA content resulted in an increase of erosion rate of PVC at  $30^\circ$  impingement angle. At the impingement angle of  $90^\circ$ , a circular erosion regions were observed, which have almost equal area for pure and 25 wt.% VA filled PVC. However, a darker colour was seen in erosion area of pure PVC which could be attributed to embedding pits produced by impingement particles.

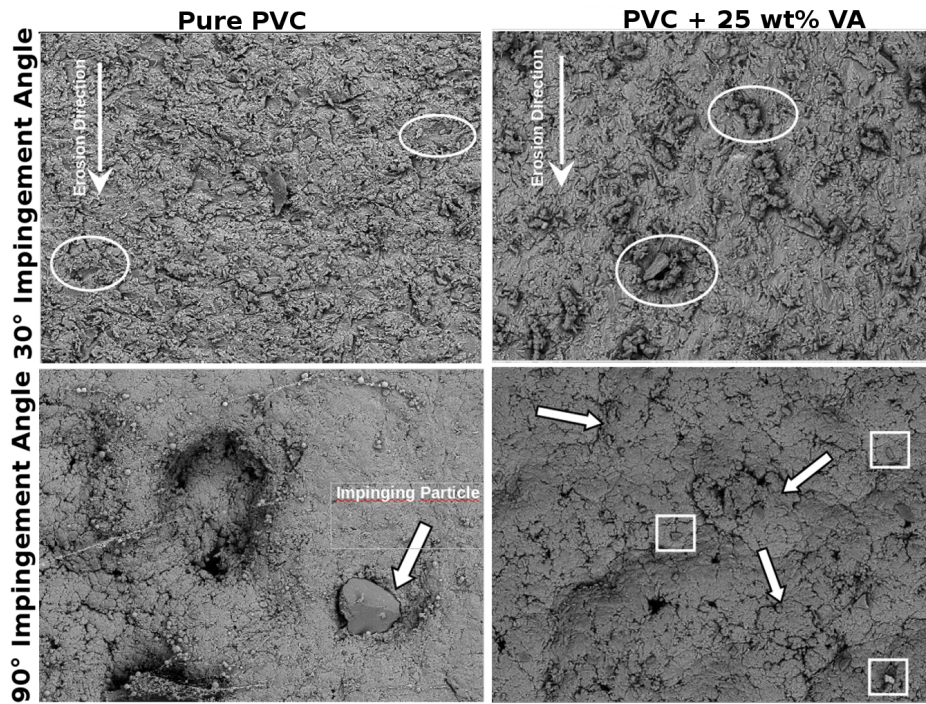
Fig. 4. SEM photographs (250×) of pure and 25 wt.% VA-filled PVC, eroded at 30° and 90° impingement angles.

Surface morphology investigation of eroded surfaces was done to ascertain the wear mechanisms at  $30^\circ$  and  $90^\circ$  impingement angle. Surface morphologies indicate whether erosion has occurred by a ductile or brittle mechanism. In Fig. 4 surface photographs of pure and 25 wt.% VA-filled PVC samples eroded at  $30^\circ$  impingement angle show, that micro-cutting, micro-ploughing and material removal in the form of micro-chunks (white ellipses) have occurred during the erosion. It is clear that micro-chunks were seen to be more dominant with VA filler addition, because it is easy for matrix to break

Erosion mechanisms of plastic deformation and micro-cracking (small white arrows) with fatigue failure were detected for impingement angle of 90°. Embedded impinging particles (big white arrow) were detected on pure
