Special Issue of the 8th International Advances in Applied Physics and Materials Science Congress (APMAS 2018)

Cavitation Erosion Damage Characteristics of Electroless Nickel Plated Gray Cast Iron

Cavitation erosion damage behaviors in the coolant of electroless nickel plated diesel engine cylinder liners were investigated. In the case of electroless nickel coating, pitting damage was locally induced by cavitation erosion attacks. The pitting damage was promoted as galvanic corrosion accompanied it. Continued cavitation erosion attacks led to the plastic deformation, fatigue, and failure of electroless nickel coating. Consequently, local pitting damage to electroless nickel coating showed a tendency to progress in the depth direction so that the surface damage depth developed greatly.

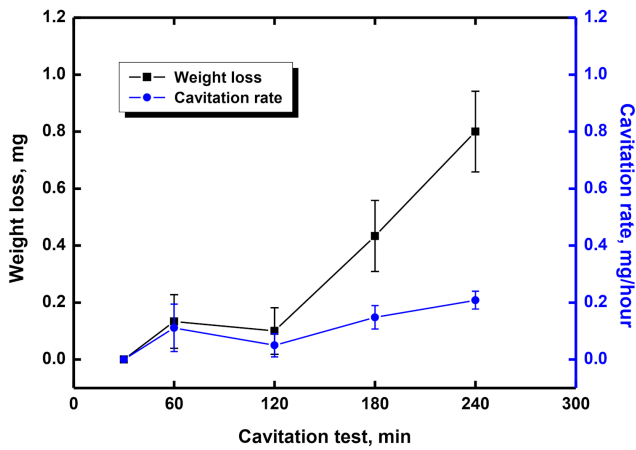
Fig. 3. Weight loss and cavitation rate of EN plated specimens with cavitation erosion time.

Figure 3 is a graph that presents weight loss and cavitation rate of EN plated specimens with cavitation erosion time. Since almost no weight loss appears up to 120 min of cavitation erosion time, the 120 min section is judged to be the incubation period presented by Thiruvengadam [13]. In the case of cavitation damage, the shock waves and micro jets occurring when cavities collapse repeatedly hit the material surface leading to fatigue, failure, and material losses. In this case, the period before the fatigue effect due to the accumulation of cavitation shocks is called incubation period. Therefore, longer incubation periods means more excellent cavitation resistance. When cavitation erosion time of 120 min had passed, an acceleration period appeared in which the weight loss increased almost proportionally with cavitation erosion time. The cavitation damage rate was shown to be almost constant with cavitation erosion time and in the case of cavitation erosion time of 240 min with the highest damage rate, the cavitation damage rate was measured to be very low as 0.2 mg/hour indicating that the cavitation resistance of EN coating is excellent.

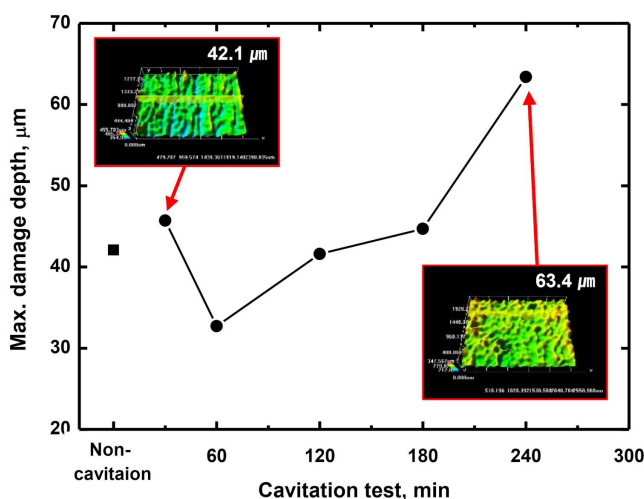
Figure 5 exhibits a graph of surface damage depths drawn after analyzing the surface damage of EN plated specimens in a coolant with cavitation erosion time using a 3D microscope. The surface damage depth showed a tendency to increase in general with cavitation erosion time. Unusually, however, at cavitation erosion time of 60 minutes, the surface damage depth was measured to be smaller than the substrate damage depth. This is judged attributable to the fact that as the uneven bumps formed on the EN coating surface during the plating process were removed so that the EN coating surface becomes evenner than the substrate. Therefore, as shown in Fig. 3, the weight loss showed a tendency to temporarily increase a little at cavitation erosion time of 60 minutes. Thereafter, as the pits formed on the surface continuously grew with cavitation erosion time, the surface damage depth showed a tendency to increase. Eventually, when the experiment was completed, due to the tendency of local pitting damage, the maximum damage depth of $63.4\ \mu\text{m}$, which is larger by $21.3\ \mu\text{m}$ than the damage depth on the substrate, was observed on the EN coating surface.

Fig. 5. 3D microscope analysis of surface damage of EN plated specimens with cavitation erosion time.
